# **Learning from Accidents**

**Trevor  
Kletz**

Third edition

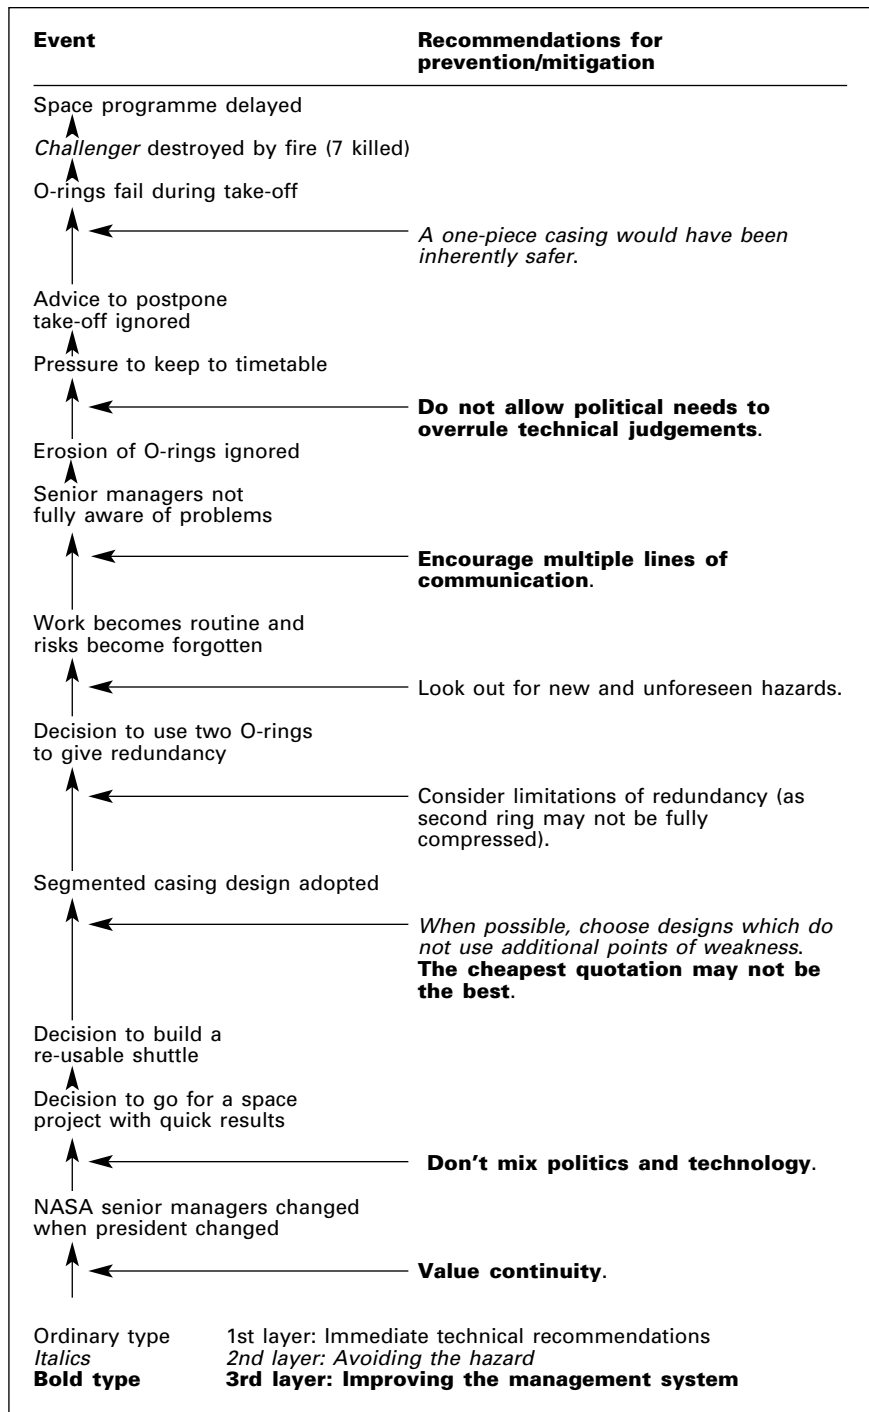
Figure 21.10 *Challenger*

The story is summarised in Figure 21.10, though some of the events occurred simultaneously rather than in the order indicated. It started about 1970 when President Nixon decided to go ahead with the construction of a re-usable space shuttle. Unlike President Kennedy he was not a space enthusiast and decided to back a project that, he hoped, would bring him credit during his term of office, rather than a long-term project such as an expedition to Mars. About the same time many of the senior staff

NASA accepted the cheapest quotation for the design of the shuttle even though the casing would be made in parts. One of the four quotations was for a one-piece design, an inherently safer one as its integrity does not depend on additional pieces of equipment, seals, which are

inevitably weaker in nature than the parts they join. The failure of one of these O-ring seals led to the loss of *Challenger*.

The first flights showed that the O-rings became eroded but this caused little concern among the senior management. Development of a new design, a 27-month programme, was started but meanwhile the old design continued in use, for several reasons<sup>7</sup>:

Finally, on the day before the fatal launch several engineers urged that it should be postponed as the temperature was below freezing and the O-rings would be brittle and more likely to fail. They were overruled, for the same three reasons. Several writers have suggested that the pressure to keep to programme came from President Reagan, as he was due to make a State of the Union Message later that day and would have liked to report a successful start to the flight. However, it is equally or more likely that the senior staff at NASA *thought* they were being pressured.

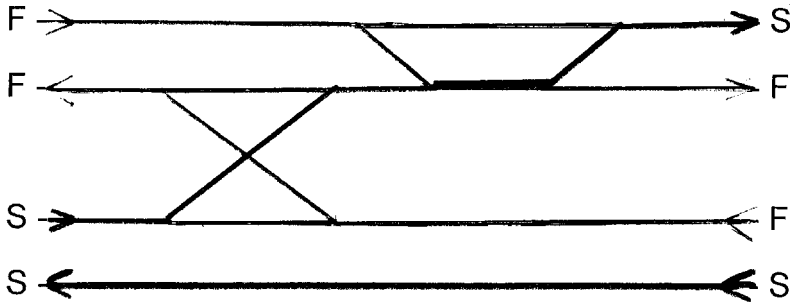
Most SPADs, over 99%, do not result in accidents<sup>9</sup>. When one train is following another down a line the first train is usually well ahead. SPADS are most likely to result in an accident when there is a conflicting movement, that is, one train has to cross the path of another<sup>10</sup>. Such movements are inevitable at junctions, unless one line is bridged over

**Figure 23.1** An example of railway track which requires conflicting train movements. The layout has now been changed. F = fast, S = slow

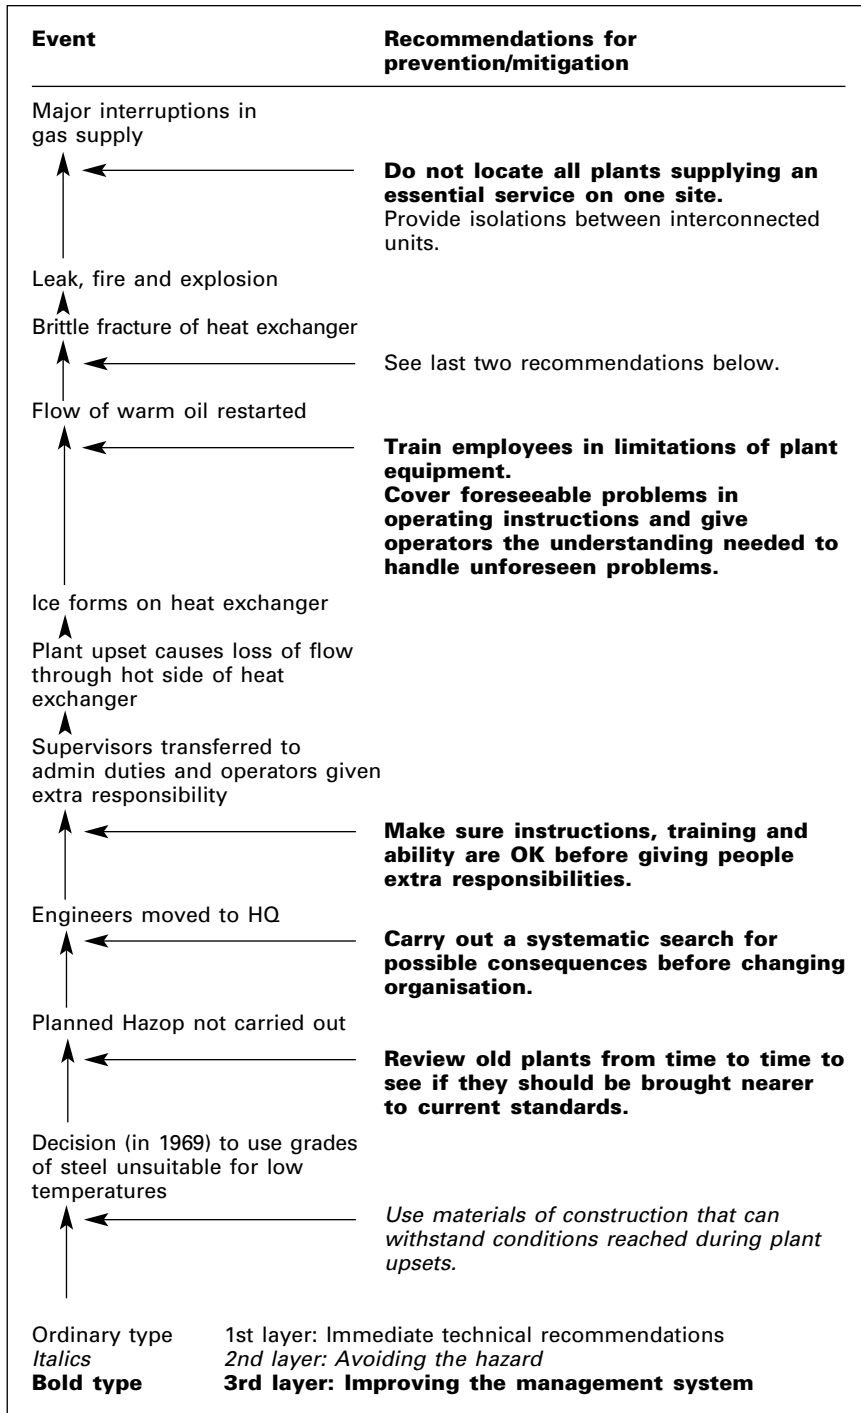
Figure 24.1 Summary of Chapter 24 – Longford

An article by Chris Green on the problems that beset Britain's railways following privatisation<sup>5</sup> shows similarities to Longford. He writes:

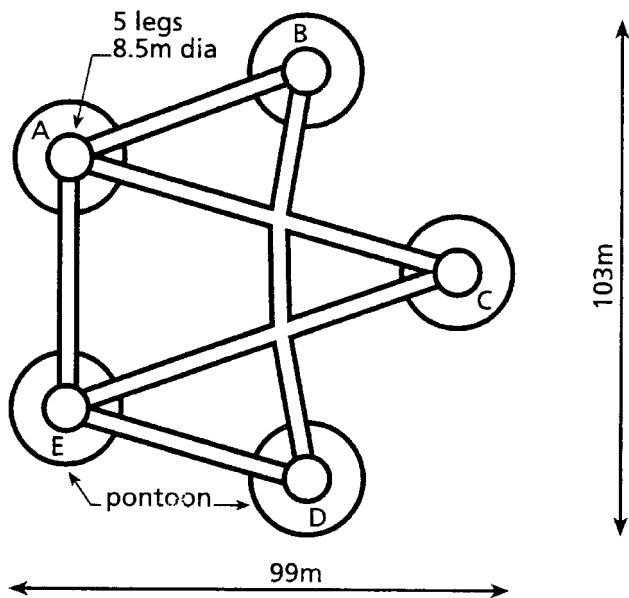
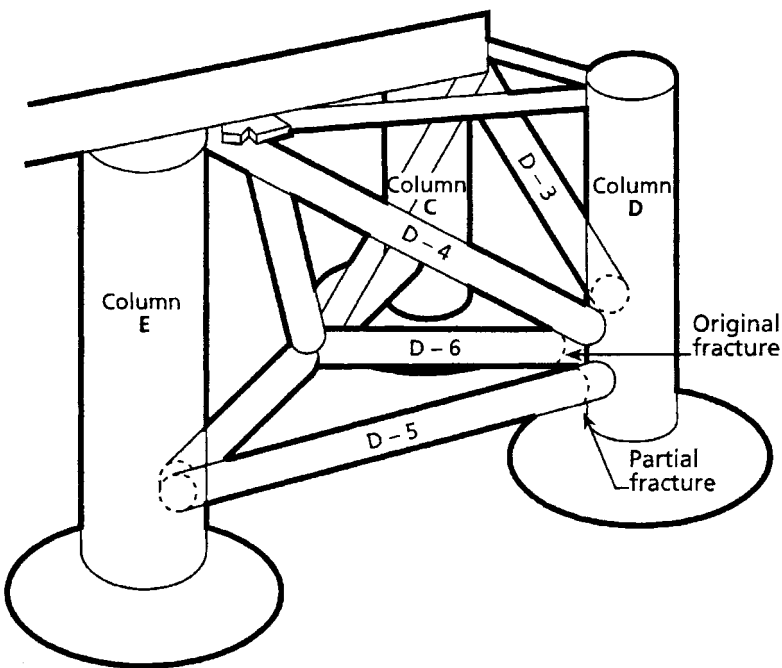
The rig was semi-submersible. In use the pontoons (Figure 28.2) were full of water and the rig was partly submersed in the water for maximum stability. When being moved the pontoons were pumped out and the rig rose 21 m higher. Though designed as a drilling rig it was being used only for accommodation. During a heavy storm in March 1980 column D, like the others 8.5 m diameter, broke and the rig turned upside down. There were 212 men on the rig at the time; 123 of them died.

**Figure 28.2 (a)** The pentagon design of the Alexander Kielland offshore rig (Reproduced with permission from Macmillan<sup>3</sup>)

**Figure 28.2 (b)** Close-up of columns C, D and E showing bracing (Reproduced with permission from Macmillan<sup>3</sup>)

The immediate cause was a fatigue crack at the position shown in Figure 28.2 which spread right round the circumference. This so weakened the structure that the other bracings cracked, the rig listed 30–35°, water entered the superstructure and 20 minutes later the rig tipped right over.

- The pentagon design was known to be prone to failure when waves came in the BD direction, the direction at the time of failure. Such rigs were normally anchored in another direction. However the Alexander Kielland was connected by gangway to a platform and was not free to change its position.
- Other rigs of the same design had been given extra bracing.
- The change in use to accommodation had increased the weight of the rig, especially above column D, making the rig less stable. (Many other rigs were said to have increased their weight since construction.)
- Pumping water into D pontoon when the rig started to list would have stabilised it.

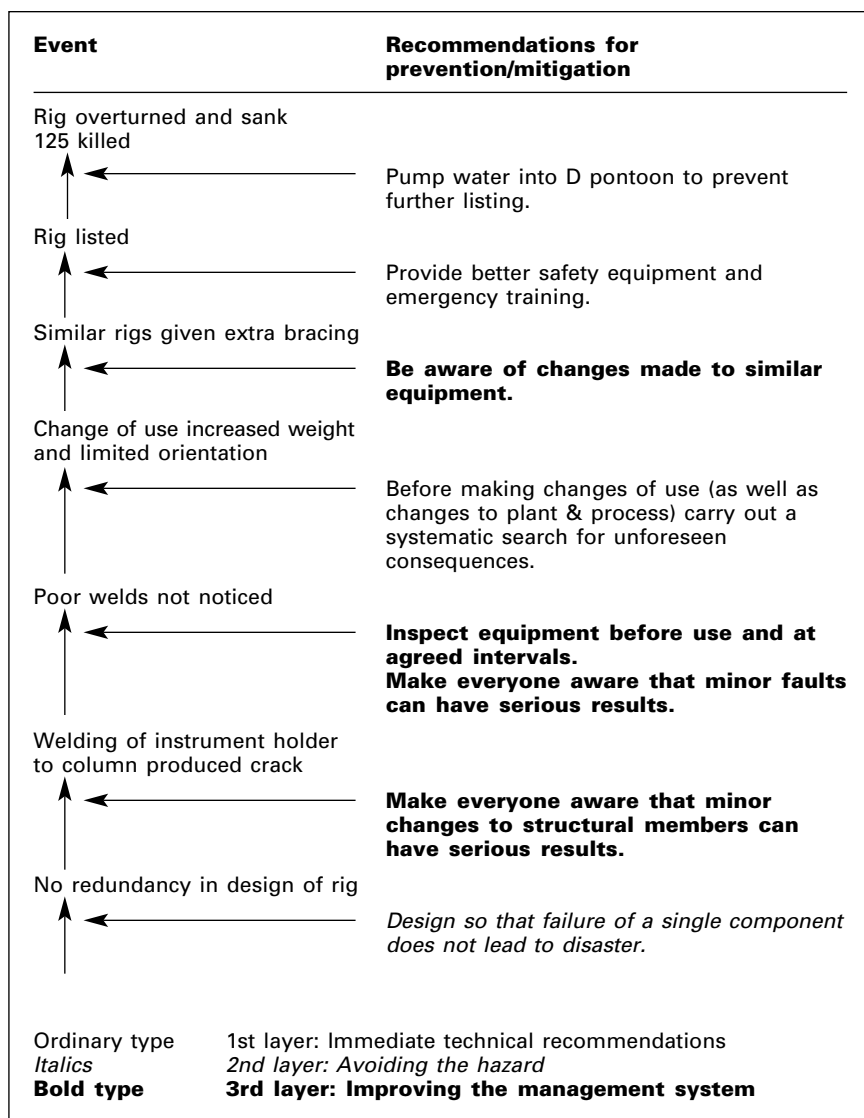
**Figure 28.3** Summary of Section 28.4 Sinking of a North Sea floating rig

Figure 28.3 summarises the various opportunities that were missed for preventing the collapse or minimising the consequences. Foremost among these were the failure to look thoroughly and systematically for the consequences of the change in use and failure to realise that changes that look trivial can sink a ship.
